Manhole Inspection Summary

Manhole # S04II2001MH

Insp Date: **8/9/06 12:00 AM**

Location Address: **3301 BONNIE RD**

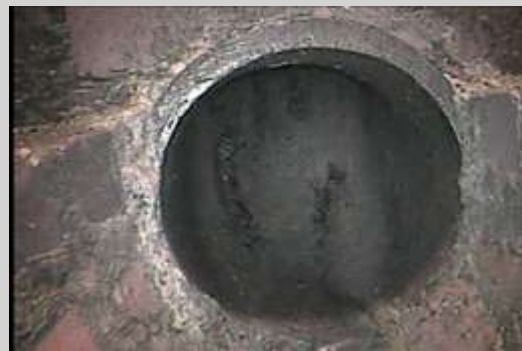
Drop In @ 3 O'Clock

Drop: **Outside** Rod and Bar

Angled: **Yes** Reading: **10.05** (ft.)

Inv Depth: **11.05** (ft.)

Drop Condition: **Open**

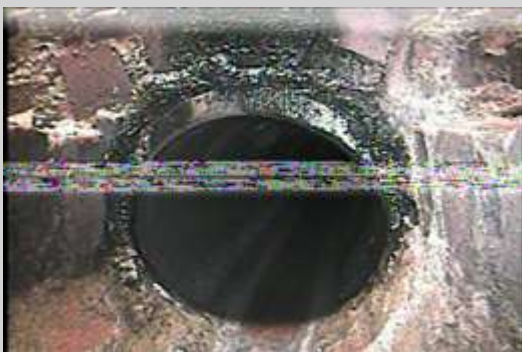
8 in. Circular Gravity Sewer

Infiltration: **None** Pipe Seal Cond: **Unknown**
